NATIONAL TRANSPORTATION SAFETY BOARD
Office of Aviation Safety
Washington, D.C. 20594

POWERPLANT GROUP CHAIRMAN'S FACTUAL REPORT

NTSB No: DCA13MA120

Aircraft: Boeing 777-200ER, Registration No. HL7742, Asiana Airlines, Flight 214

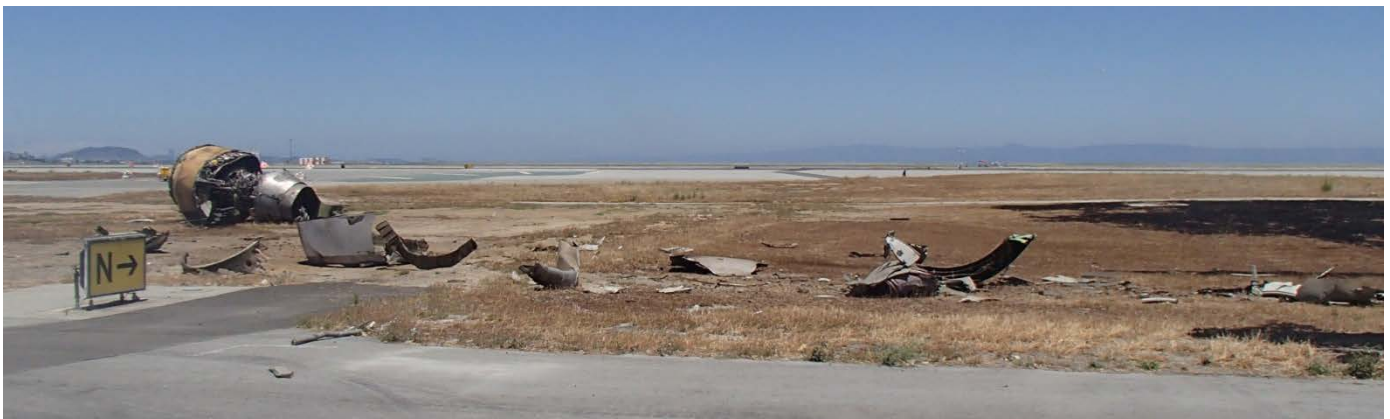
The airplane came to rest to the left of runway 28L, right side up and with the nose of the airplane pointing northwest. The left engine with the pylon still attached was found separated from the wing and resting on its right side. The engine was located approximately 600 feet north of the main wreckage on the opposite side (right side) of runway 28L (**Photo 1**). Ground scars were noted on the runway and into the grass to the right of runway 28L where the engine had skidded after separation from the wing. Fan blade fragments were found in a localized area on the runway in-line with the engine ground scar tracks (**Photo 2**). Separated sections of the engine cowls and thrust reverser were also located on the runway and in the grass leading to the engine.

Photo 1- Left Engine, Right of Runway 28L

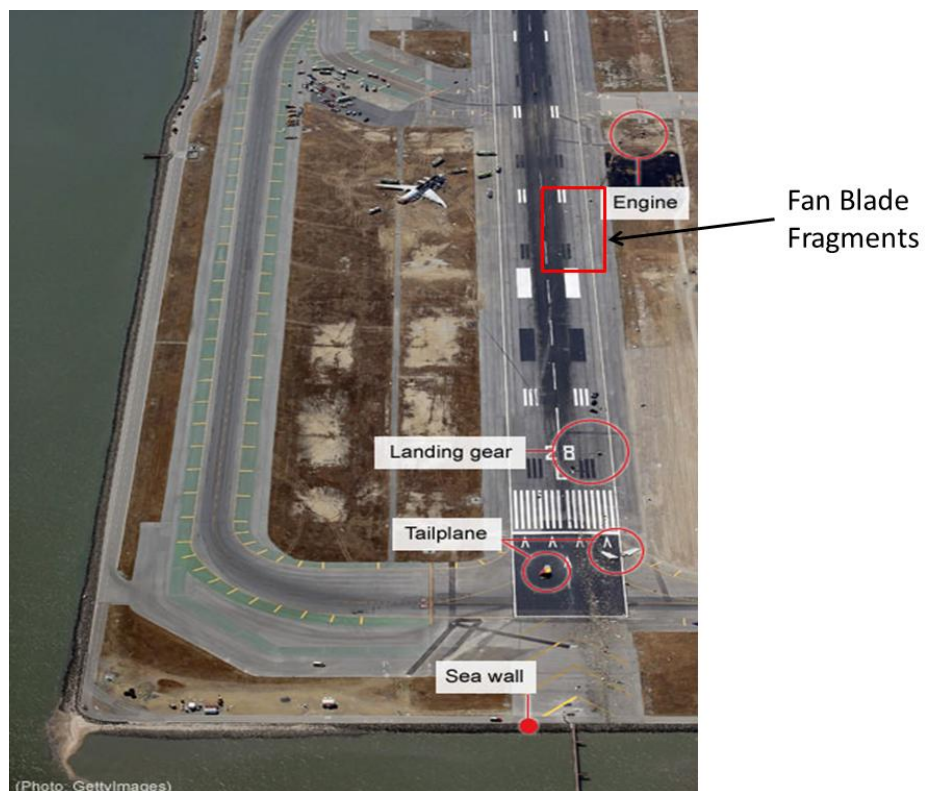
Photo 2- Aerial Wreckage Photograph, Majority of Fan Blade Fragments Recovered From Area Within the Red Box

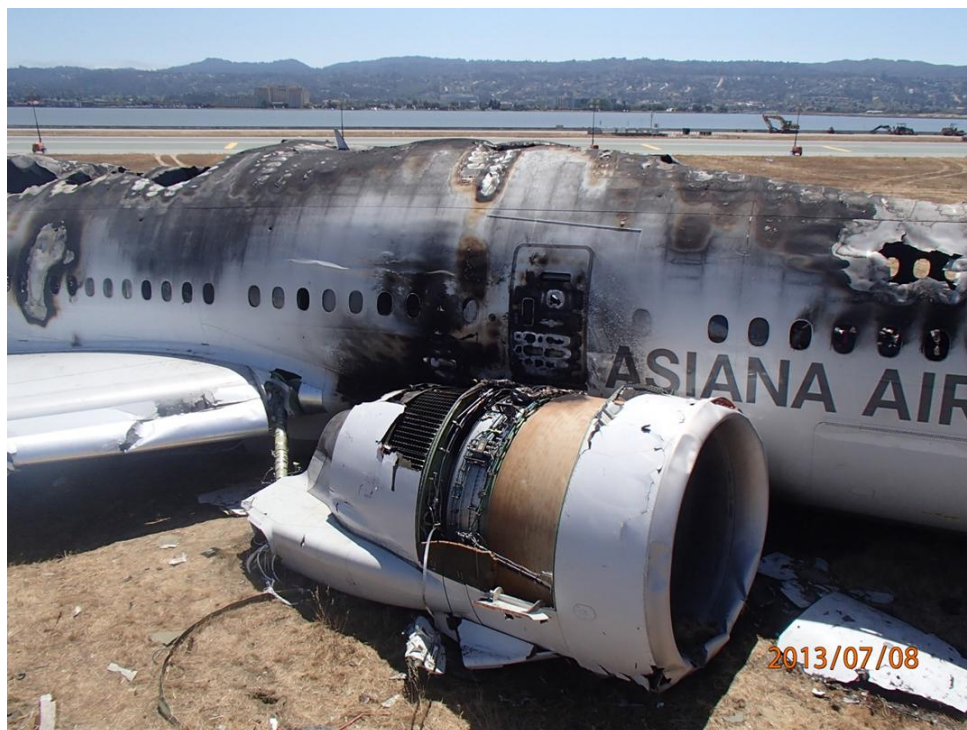
The right engine was separated from the wing and found on its right side resting against the right side of the fuselage (**Photo 3**).

Photo 3- Right Engine

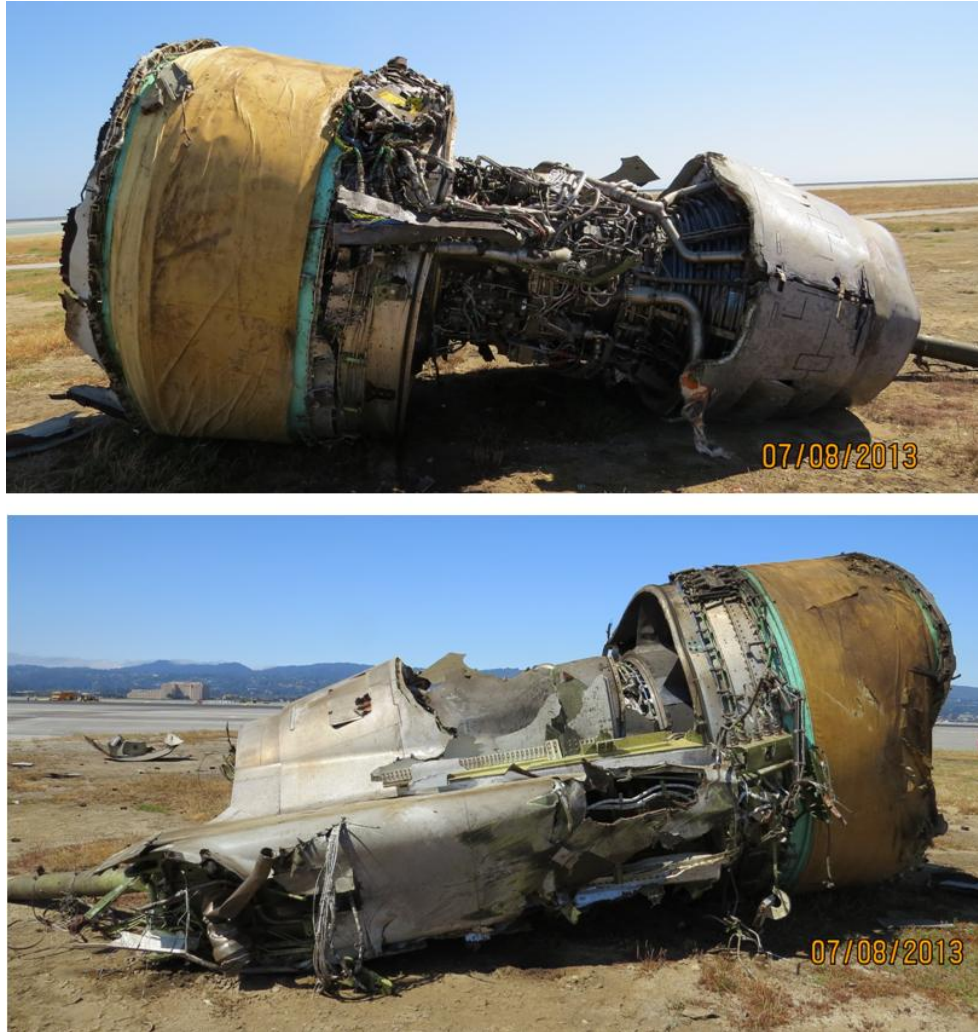
The left engine had no indications of fire or uncontainment. The engine data plate serial number located on the fan case matched Asiana Airlines records. The cowlings were separated from the engine except for an approximately six inch (axially) piece of the inlet cowl which remained attached to the 'A' flange (**Photo 4**). The thrust reverser and tail cone were separated from the engine. A visual inspection of the thrust reverser actuators confirmed it was in the stowed in the position (**Photo 5**).

Photo 4- Left Engine

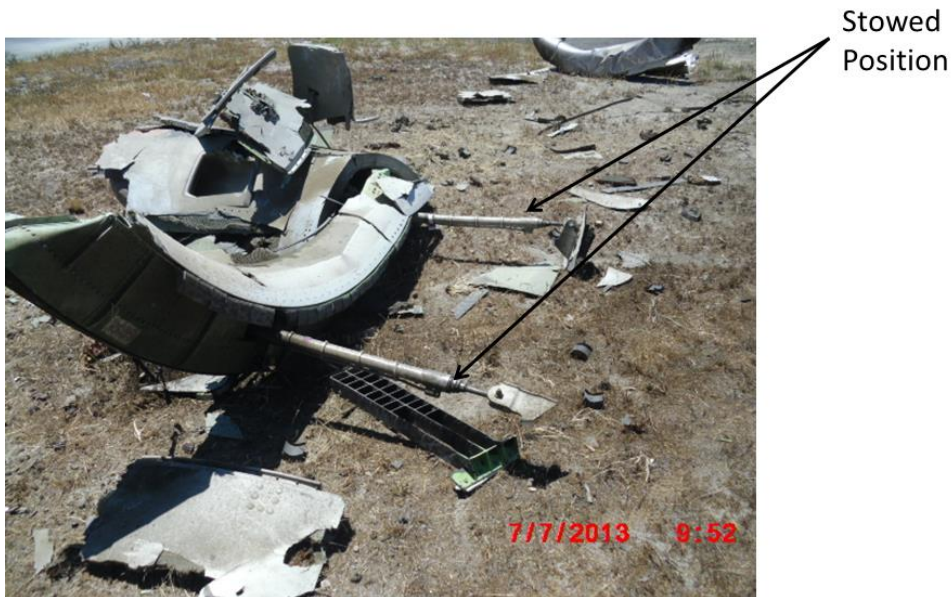
Photo 5- Left Engine Thrust Reverser Wreckage, Stowed Position

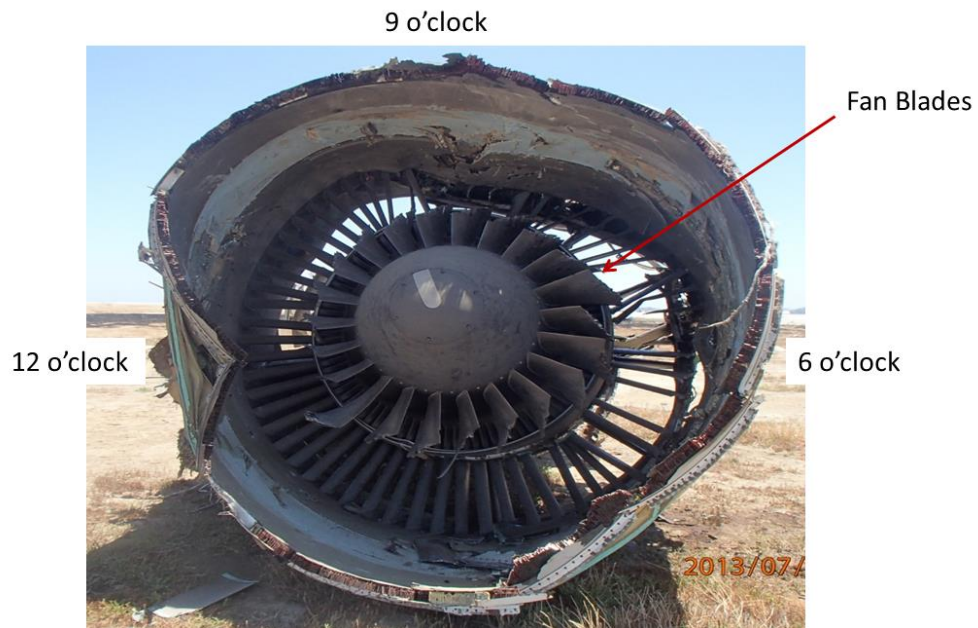
The fan case was ovalized and exhibited inward deformation at 6, 9, and 12 o'clock. All the fan blades were fractured between 8 and 20 inches outboard from the blade platform (**Photo 6**).² The fan case was fractured circumferentially from 3 to 5 o'clock aft of the 'C' flange, and 5 to 6 o'clock aft of the 'B' flange (**Photo 7**). The fan blade rub strip material located around the circumference of the fan case exhibited rubs and gouging 360 degrees around with the most severe damage located at 6 and 12 o'clock (**Photo 8**). Rub strip damage aft of the normal blade path was identified at the 6 o'clock position (**Photo 9**). The fan blade fractures and the case rub damage were consistent with high speed fan rotation at the time of impact.

Photo 6- Fan Case Ovalization and Blade Damage

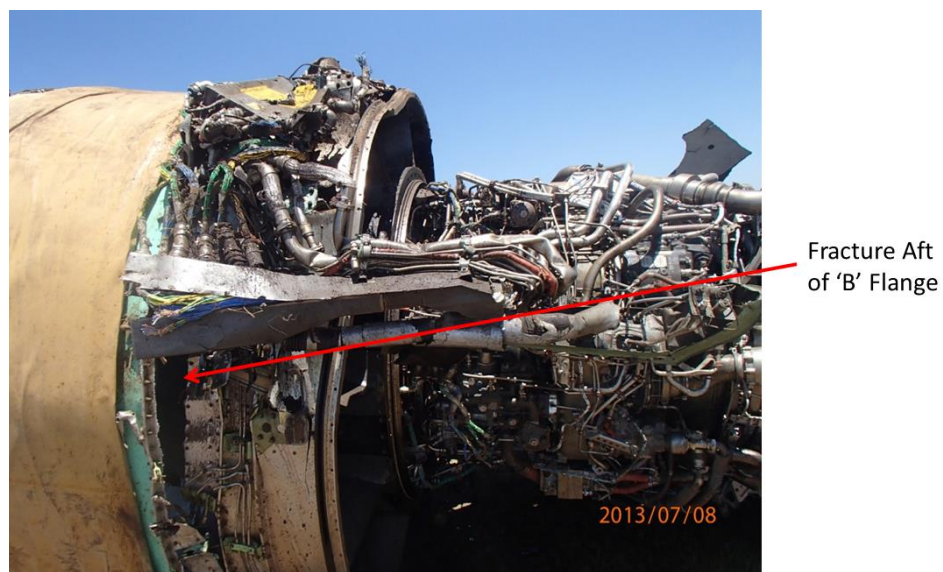
Photo 7- Fan Case Fracture Aft of 'B' Flange

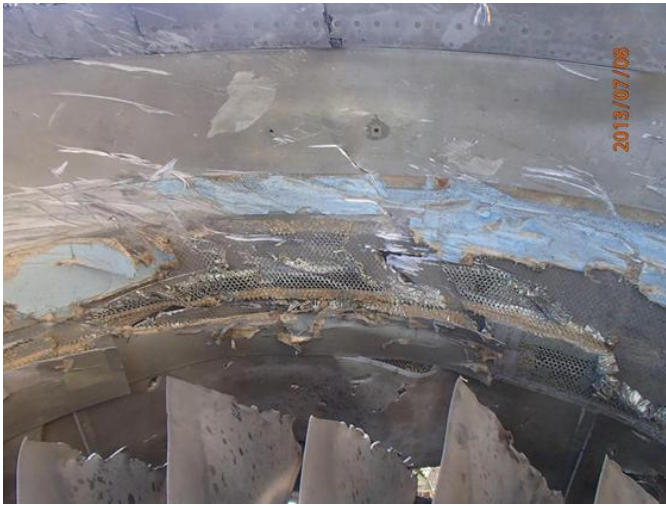
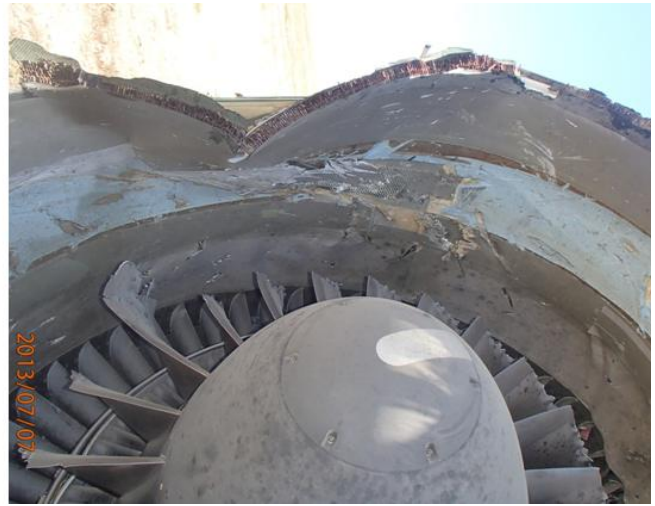
Photo 8- Fan Rub Strip- (Left) 6 o'clock, (Right) 12 o'clock

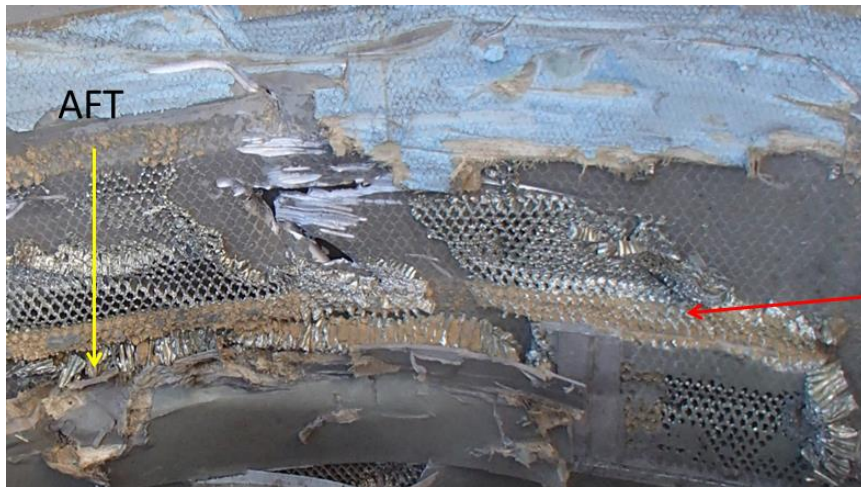
Photo 9- Close Up of Rub Damage at 6 o'clock

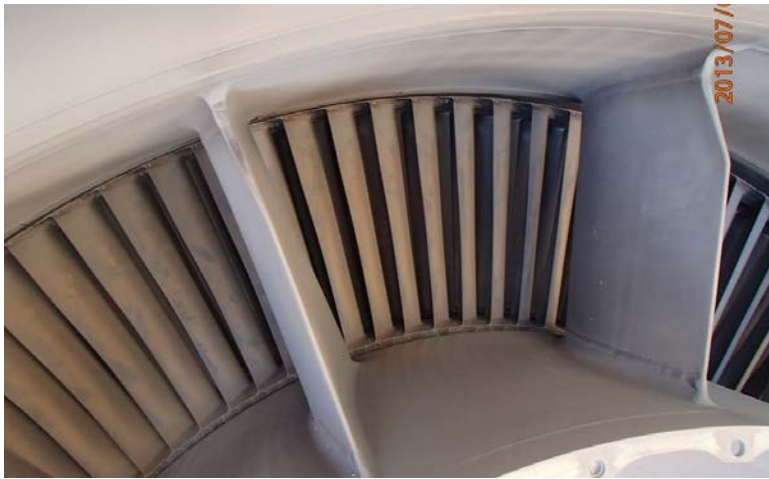
All visible LPT 7th stage blades and vanes were intact and appeared in good condition (**Photo 10**). No loose metal debris was found in the exhaust.

Photo 10- Low Pressure Turbine Blades, Intact

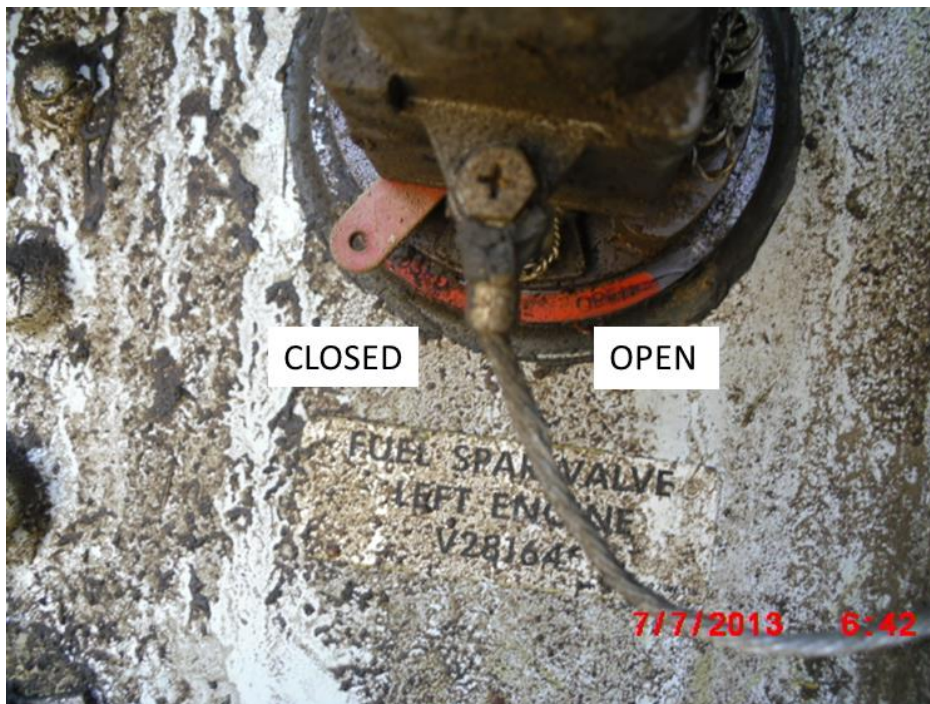
The left engine fuel spar valve³ located at the engine mount on the wing was found in the closed position (**Photo 11**).

Photo 11- Left Fuel Spar Valve, Closed Position

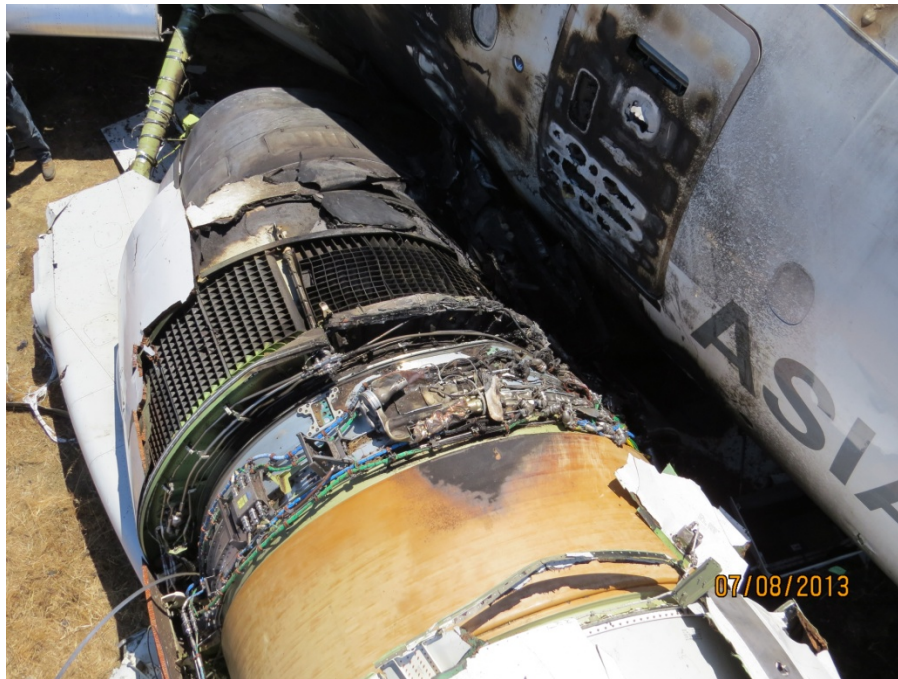
The right engine had no indications of uncontainment but exhibited thermal damage and sooting along the top and left side exterior surfaces as viewed from the engine's resting position (**Photo 12**). The oil tank located on the top of the engine was partially melted and the areas around the tank were heavily sooted and thermally damaged (**Photo 13**). The engine data plate serial number located on the fan case matched Asiana Airlines records. A visual inspection of the thrust reversers confirmed they were in the stowed position (**Photo 14**).

Photo 12- Top View of Engine with Thermal Damage on Left Side

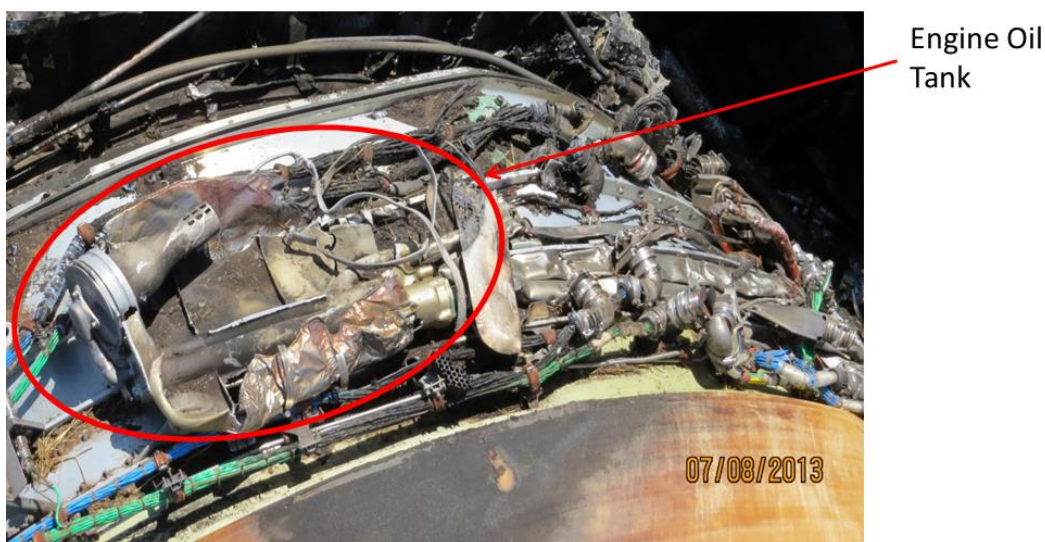
Photo 13- Engine Oil Tank Location, Thermally Damaged

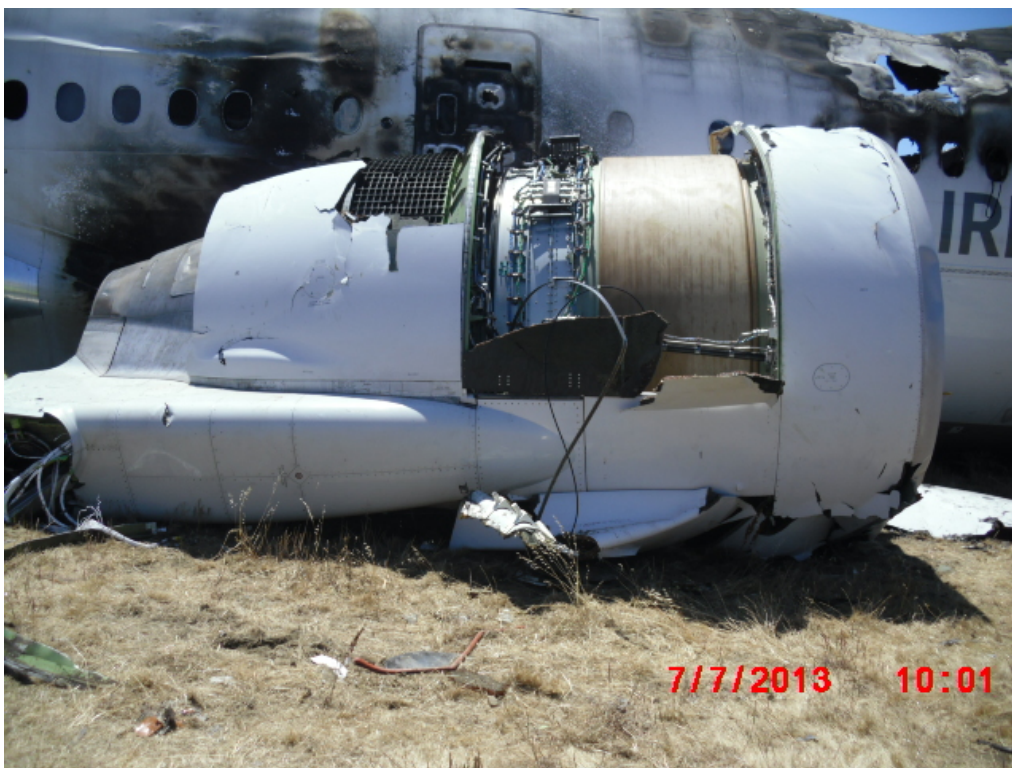
Photo 14- Right Engine, Thrust Reverser in Stowed Position

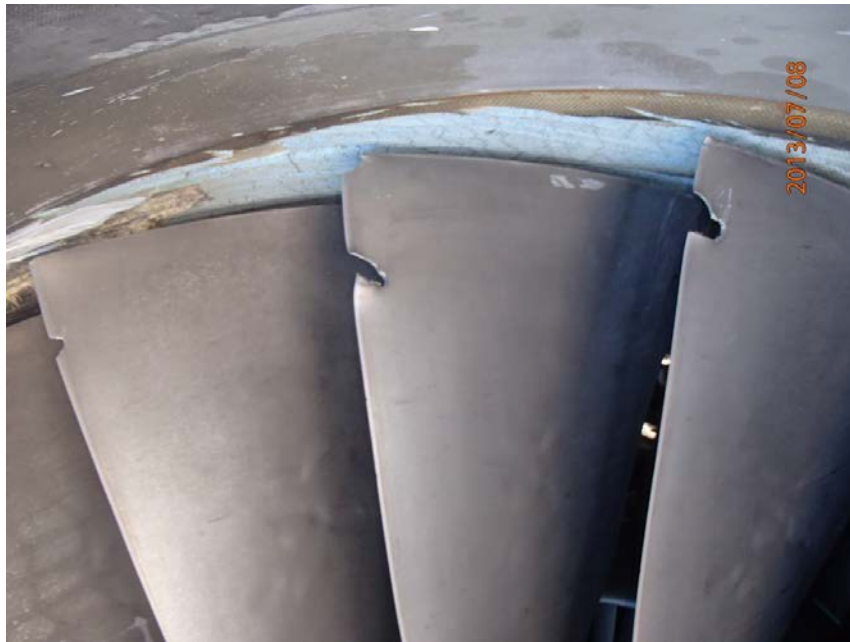
The fan blades were intact but exhibited varying levels of hard body impact damage on the leading edge consistent with foreign objects entering the fan while the engine was rotating at high speed (**Photo 15**). Multiple fan blade tips exhibited curling opposite the direction of rotation. The fan case rub strips had gouging and rubs 360 degrees around but was most severe from 3 to 6 o'clock (**Photo 16**). Fan blades and fan exit guide vanes exhibited sooting and thermal deformation in the upper left quadrant (9 to 12 o'clock) as viewed from the engine's resting position, consistent with thermal distress that was seen on the external engine surfaces (**Photo 17**).

Photo 15- Fan Blade Leading Edge Damage

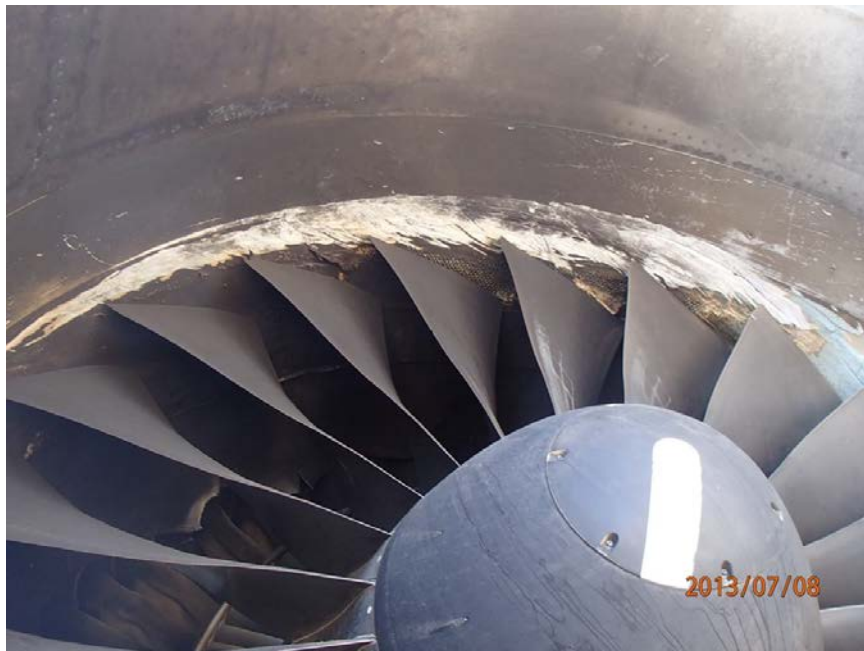
Photo 16- Fan Blade Rub Strip, 3 to 6 o'clock

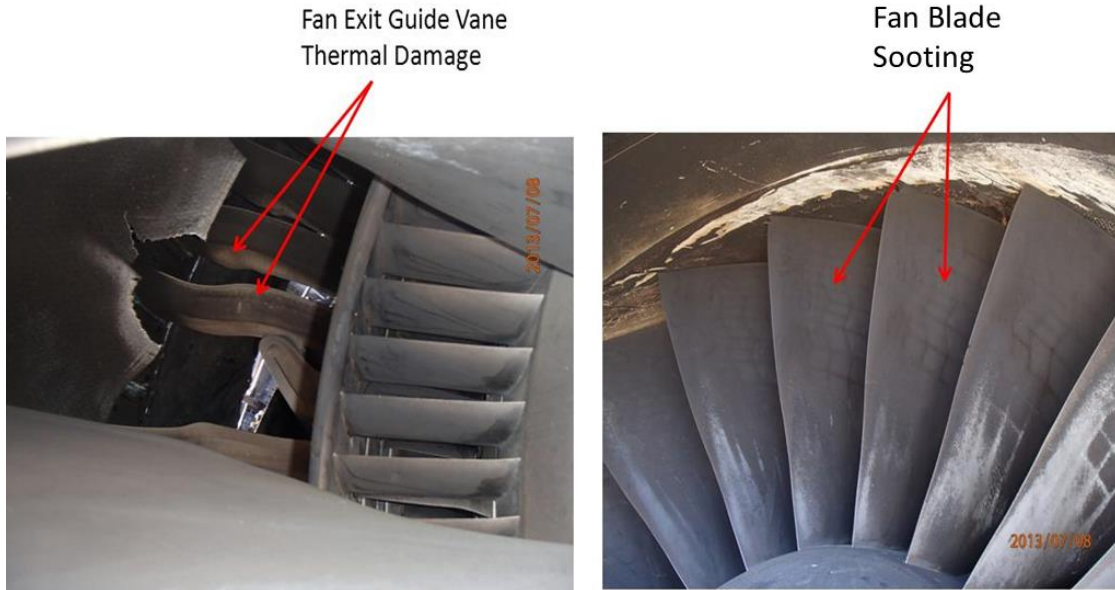
Photo 17- Fan Blade Rub Strip, 3 to 6 o'clock

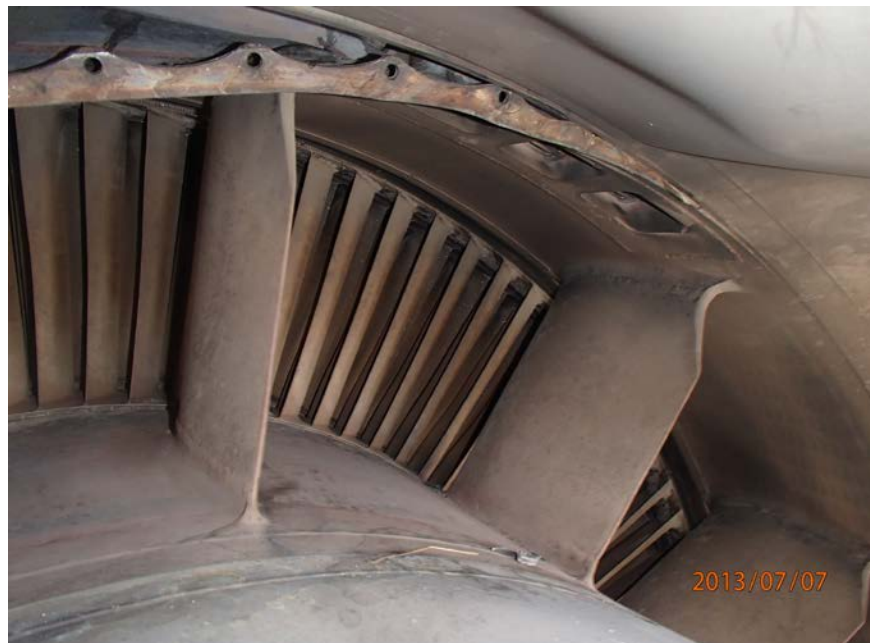
All visible LPT 7th stage blades and vanes were intact and appeared in good condition (**Photo 18**). No loose metal debris was found in the exhaust.

Photo 18- LPT Blades, Intact

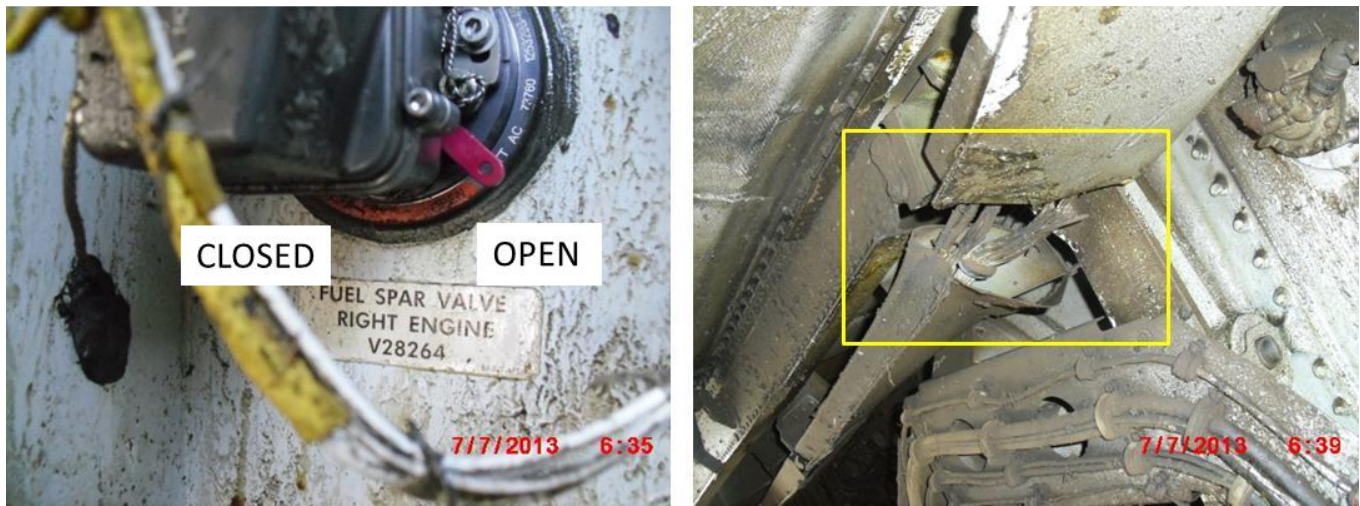
The right engine fuel spar valve was in the open position. The wiring to the spar valve actuator was separated (**Photo 19**).

Photo 19- (Left) Right Fuel Spar Valve, Open (Right) Wire Bundle Separated

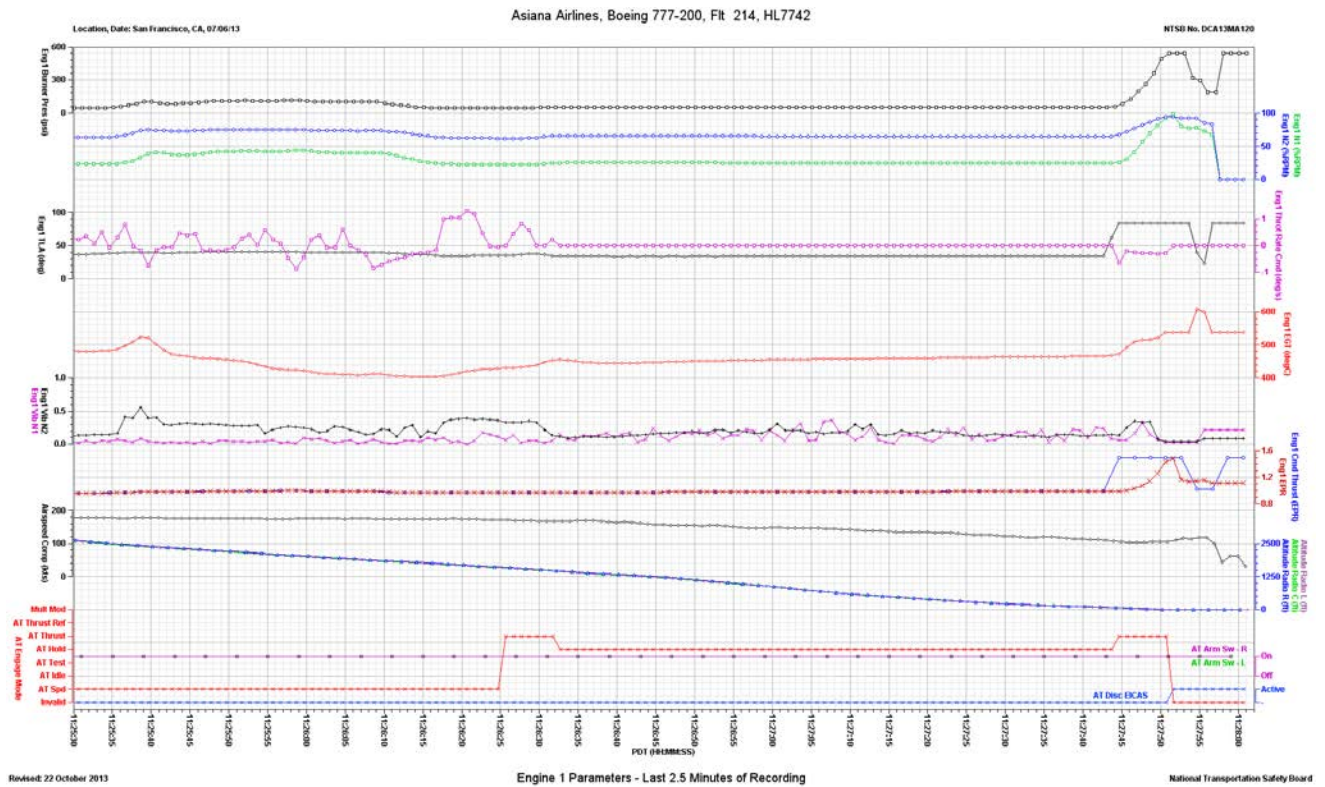
Figure 2- Left Engine FDR Plot

The FDR was downloaded and analyzed at the NTSB Vehicle Recorders Lab in Washington, DC. Key engine parameters were plotted to examine whether the engines were operating according to design specifications prior to impact (**Figures 2 and 3**)^{4,5}. During approach both engines' TLA and N1 parameters were at idle. The crew advanced both engine throttles to attempt a go-around. When the throttles were fully advanced, 90% N1 thrust levels were reached in approximately 6 seconds by the left engine and approximately 7 seconds by the right engine (**Tables 2 and 3**). The acceleration time for both engines met the performance requirement stated in the design specification.

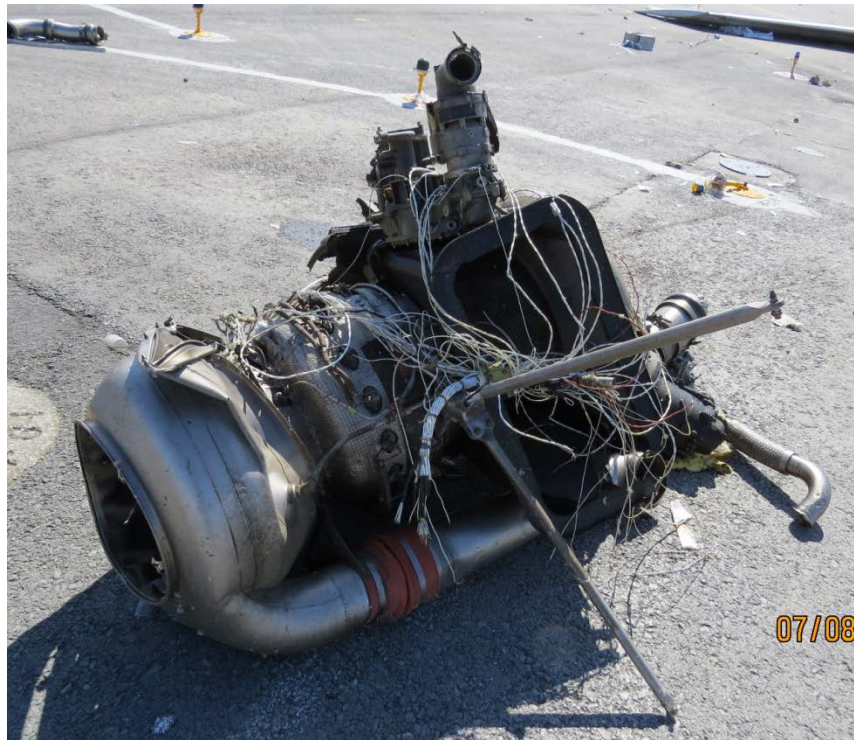
The APU was found separated from the airplane on the right side of the runway 28L center line, near the threshold (**Photo 20**). There was no evidence of fire or uncontainment. The APU was not further analyzed due to a lack of evidence suggesting it was a causal factor in the accident.

Photo 20- Auxiliary Power Unit
